ENVIRONMENTAL STUDY REPORT  
CLASS ENVIRONMENTAL ASSESSMENT

**REMEDIAL FLOOD CONTROL WORKS  
MILLBROOK DAM**

**OCTOBER 2013**

*Prepared for: Otonabee Region Conservation Authority and the Township of Cavan Monaghan*

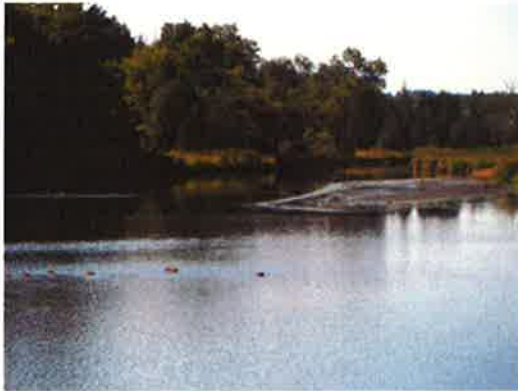
Sediment Accumulation (Upper  
Headpond) (Looking South)

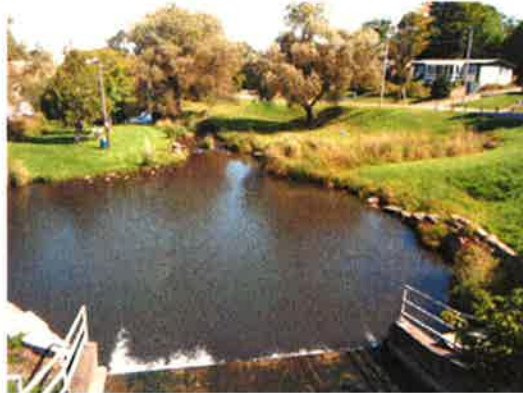
Plunge Pool and Island Below Spillway  
(Looking North)

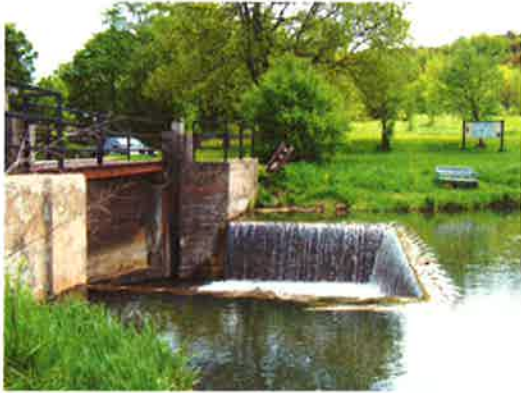
U-Shaped (Overflow) Weir (Looking East)

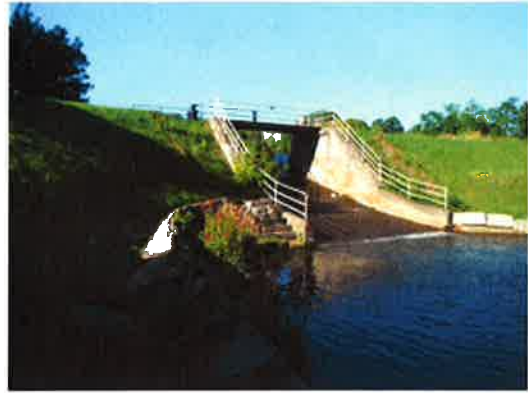
Spillway (Looking Southwest)

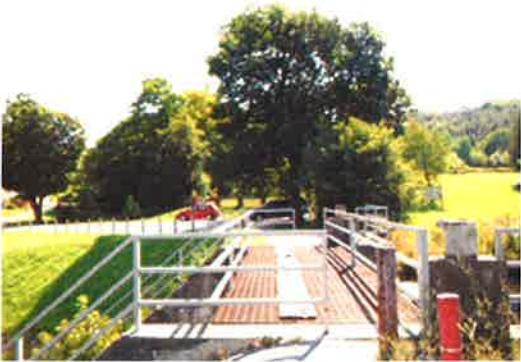
Steel Pedestrian Bridge (Looking East)

A walking path crosses the dam crest and is carried over the spillway by a steel pedestrian bridge connecting Anne Street, Distillery Street and the Medd's Mountain Conservation Area. A wooden stairway, adjacent to west side of Needler's Mill connects the walking path to the arena parking lot.

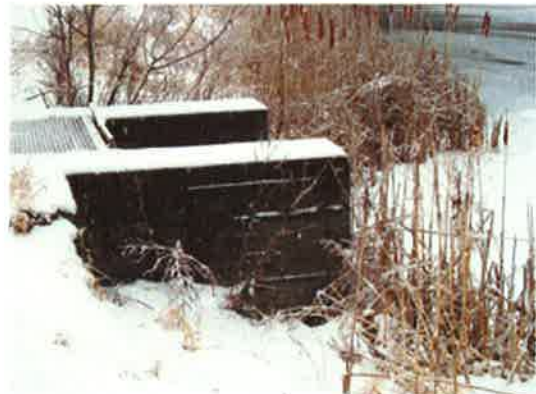
Penstock Intake (To Needler's Mill)  
(Looking East)

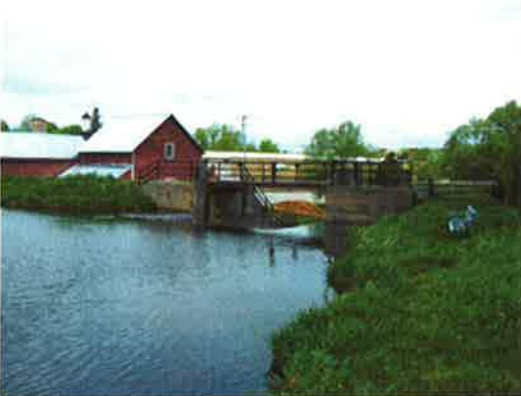
Upstream Dam Face (Looking Northwest)

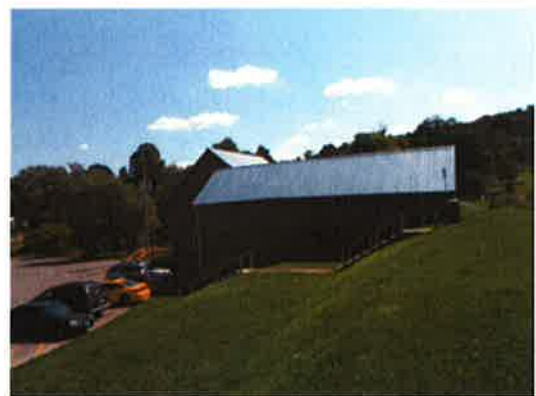
Stabilizing Berm (Looking East)

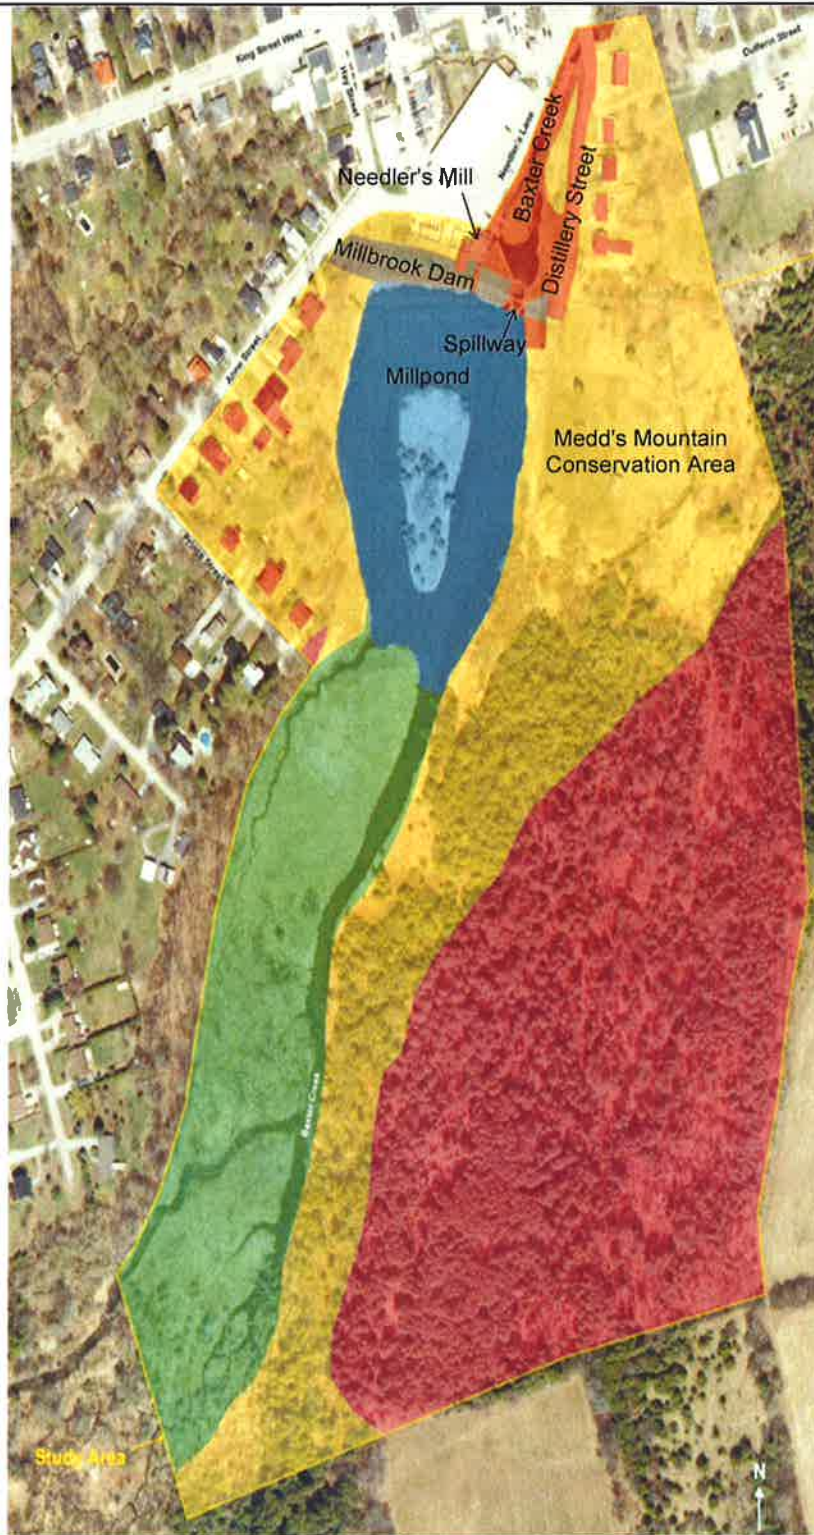
Client:	<b>OTONABEE CONSERVATION</b>	
Title:	<b>Archaeological Potential</b>	
Prepared by:	<b>MMM GROUP</b>	
14.12216.001.P01	Scale as Shown	Review: JB
Date: May 2013	<b>Figure: 7-1</b>	
© Queen's Printer for Ontario

- Archaeological potential: Stage 2 shovel testing required
  - Deeply buried archaeological potential: Archaeological monitoring required
  - No archaeological potential: permanently wet
  - No archaeological potential: dredged
  - No archaeological potential: steeply sloped
  - No archaeological potential: disturbed by construction
- Source: Past Recovery Archaeological Services (2012)

The study area is located within close proximity to several features indicative of potential for the presence of archaeological sites related to pre-contact Native settlement and other land uses (Figure 7-1). These landscape features consist of a prominent rise of land located in close proximity to Baxter Creek and its two subsidiary streams, as well as an abundance of sandy, well-drained soils.

Figure 7-1 shows areas of archaeological potential and is to be read in conjunction with the following Stage 1 assessment recommendations

- i) All areas shown in yellow on Figure 7-1 retain archaeological potential and should be the subject of a Stage 2 archaeological assessment if they are to be impacted in any way during proposed construction activities, for example through excavation, stockpiling and/or use as a staging area. As none of these areas can be ploughed, the Stage 2 assessment should be completed through shovel test pits excavated at five metre intervals.

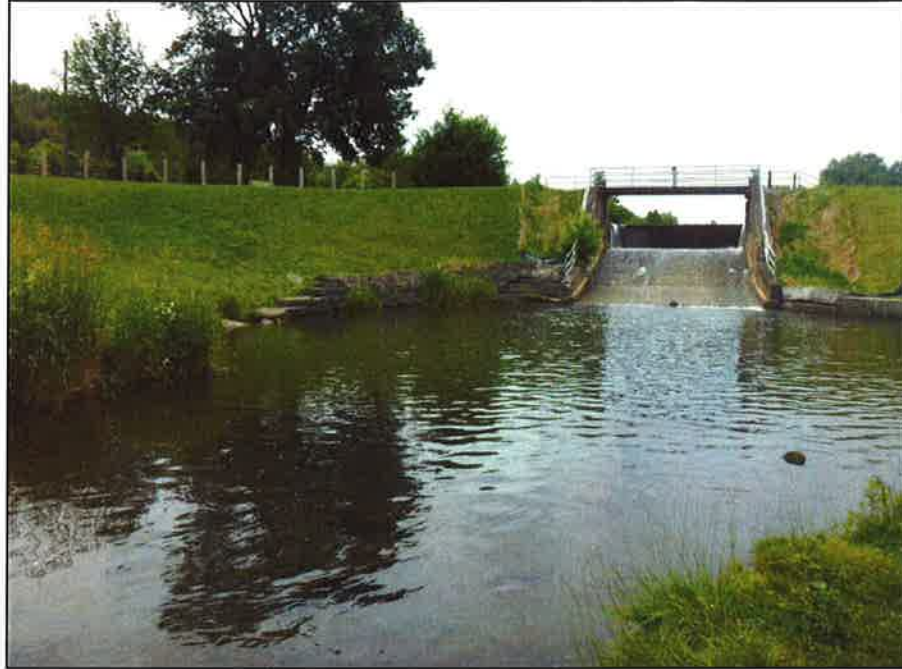
View of dam/spillway

A site visit was conducted on the 28th of June 2012. A Rapid Geomorphic Assessment was conducted on two reaches downstream of the pond (Figure 9-1). The first reach started at the pond and extended to the bridge at King Street. The second reach extended a further 100m downstream. In addition, spot checks were conducted along the downstream section between Bank Street and Centennial Lane. Upstream of the pond, spot checks were conducted near Main Street and 150m upstream from the pond inlet.

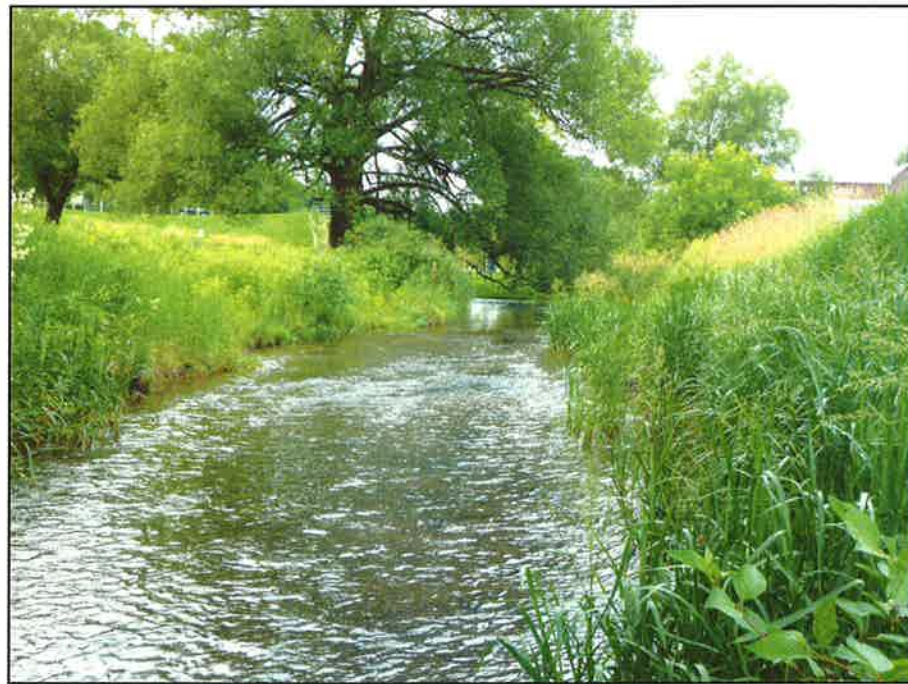
Downstream Creek Channel (Looking South)

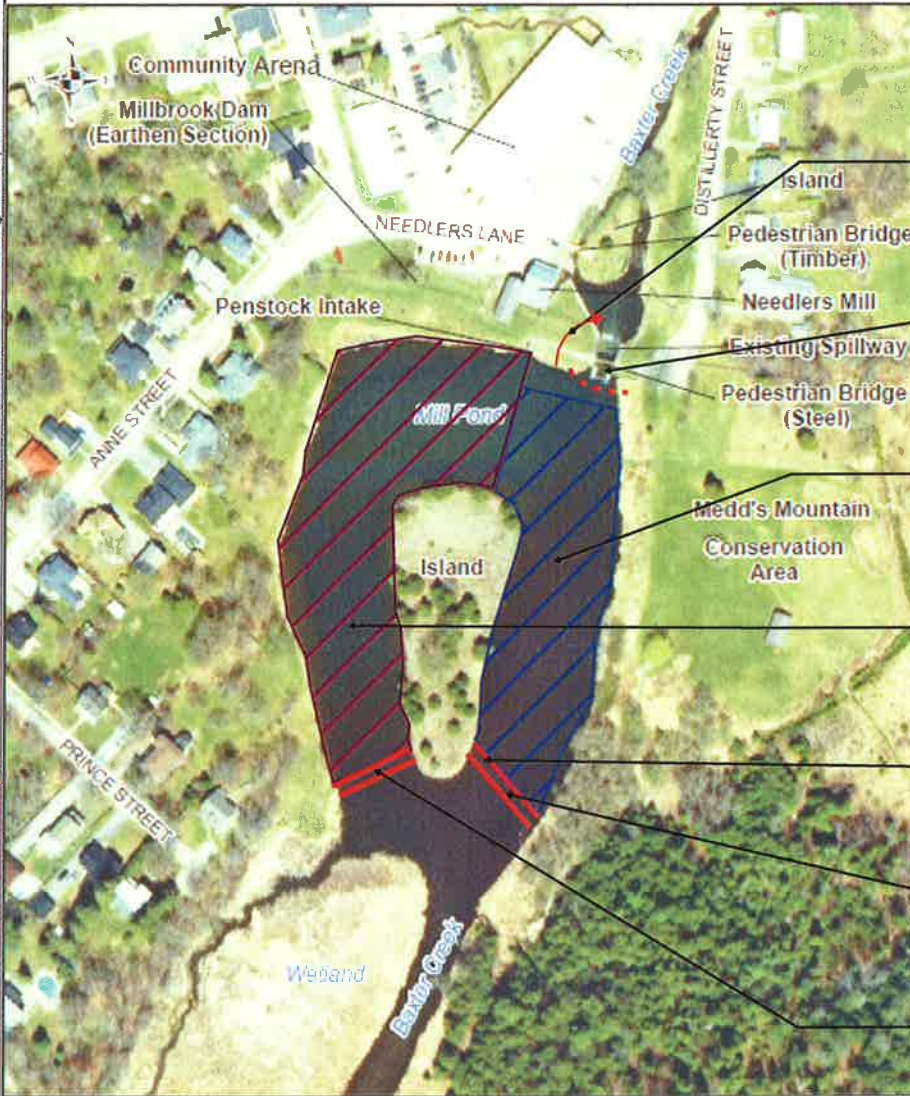
<b>MMM GROUP</b>		
14.12216.001.P01	Scale as Shown	Review: JB
Date: May 2013		<b>Figure: 13-1</b>
© 2012 Cnes/Spot Image Image © 2012 DigitalGlobe

- 2. Construct flow diversion channel
- 3. Cofferdam, excavate, construct new spillway and weir
- 6. Drain and excavate sediment (Eastern Headpond)
- 4. Drain and excavate sediment (Western Headpond)
- 5. Relocate flow diversion structure
- 7. Remove flow diversion structure
- 1. Construct flow diversion structure

Relocation of the creek/drainage channel is central to construction procedures whether the spillway is removed or, a new weir is constructed. Basically, the same steps apply to both options, but, in a different sequence. Figure 13-1 shows staging for the new weir concept. Initially, a flow diversion structure (possibly a sheet pile wall) would be constructed between the south end of the island and the mainland to speed drainage of sediments and enable excavation to the west of the island. Concurrently, a diversion channel would be constructed through the dam embankment, west of the existing spillway to carry flows safely into downstream Baxter Creek. The spillway site would then be coffer dammed. Excavation and construction of the new weir would begin. Following drainage and excavation of “west side” sediments, the sheet pile flow diversion structure would be relocated to form a barrier between the island and eastern shoreline. In doing so, Baxter Creek flows would be directed to the west of the island and through the dam’s channel diversion to downstream Baxter Creek. Once weir construction is completed the diversion channel would be filled, and the sheet pile flow diversion structure (at the island) and the coffer dam would be removed, allowing the headpond to refill and the weir to become functional.

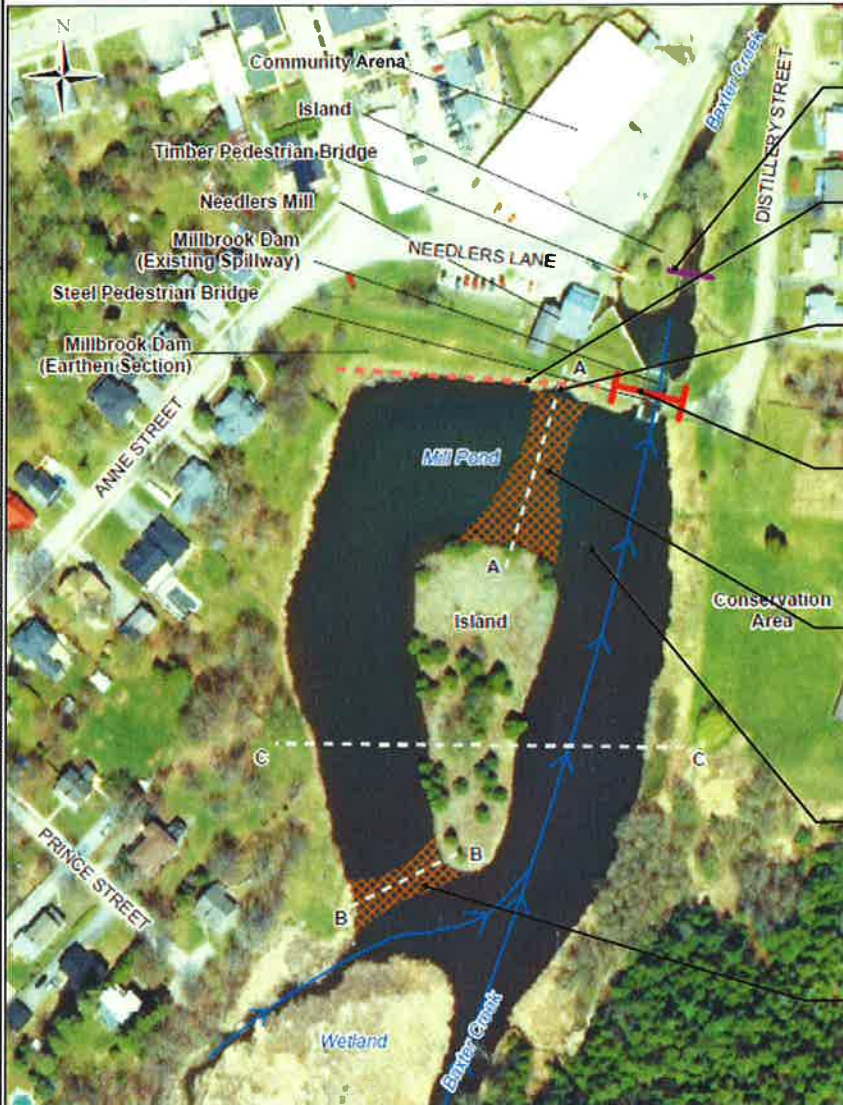
<b>MMM GROUP</b>		
14.12216.001.P01	Scale as Shown	Review: JB
Date: May 2013	<b>Figure: 13-3</b>

**Concept B Features**

- Construct New Pedestrian Bridge at Downstream Location
- Install Seepage Barrier to Protect Mill Building
- Remove Penstock intake
- Remove Dam and Widen Spillway (Remove Existing Pedestrian Bridge)
- Construct Landform "A" Using Excavated Sediment
- Excavate New Creek Channel (Natural Channel Design Is Questionable: Stepped Weir System More Likely)
- Construct Landform "B" using Excavated Sediment and Install Culvert for Flushing

Concept B (Figure 13-3) is based on similar principles utilized in Concept A as follows

- removal of the existing spillway followed by a construction of a larger spillway (as per Concept A)
- restoration of the Baxter Creek channel alignment and,

For Concept B, the spillway would again be deepened and widened as per details provided for Concept A. Similarly, the new Baxter Creek would be excavated and oriented toward the east side of the headpond and fitted with a step-pool channel design (Figure 13-3). In contrast to Concept A, a new pond would be created by excavation to the west of the island. The pond would be contained by two impermeable, earth-fill landscape features (dykes) joining the island to the headpond shoreline as shown in Cross Sections A-A and B-B (Figures 13-4). Pond elevation would be set at same elevation (215.1m) as the existing headpond. The pond would be fed from two sources:

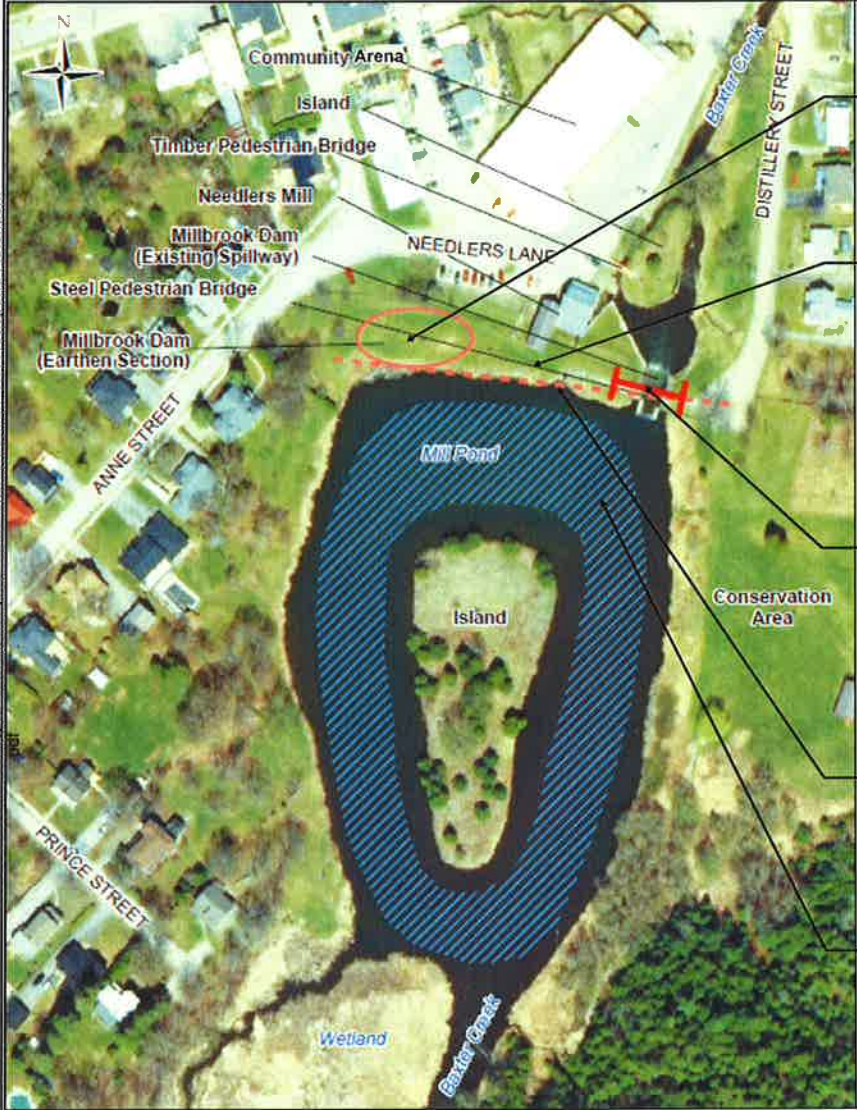
<b>MMM GROUP</b>		
14.12216.001.P01	Scale as Shown	Review: JB
Date: May 2013	<b>Figure: 13-5</b>

**Concept C Features**

Place Impermeable Fill to Reinforce West End of Dam

Install Impermeable Barrier to Prevent Seepage/Erosion of Dam Foundation

Concept C (Figures 13-5 and 13-6) is based upon:

- replacement of the existing spillway with a new weir capable of passing the required design flows
- retention of the headpond and,
- headpond sediment removal
- retention of as many social functions/features as possible.

- additional repair of earthen embankment is needed. Two repairs (Figure 13-5) are required to improve stability of the embankment including:
  - i) installation of an impermeable barrier to prevent seepage beneath the dam. The barrier would extend from the west side of the new spillway to the west end of the earthen embankment, and, from the east side of the new spillway to the east end of the dam. Sheet pile is a likely choice of construction material.
  - ii) placement and extension of the reinforcing/stabilizing berm near the west end of the embankment
